PARKING LIGHT WIRE - (2000-2005 IMPALA AND MONTE CARLO)

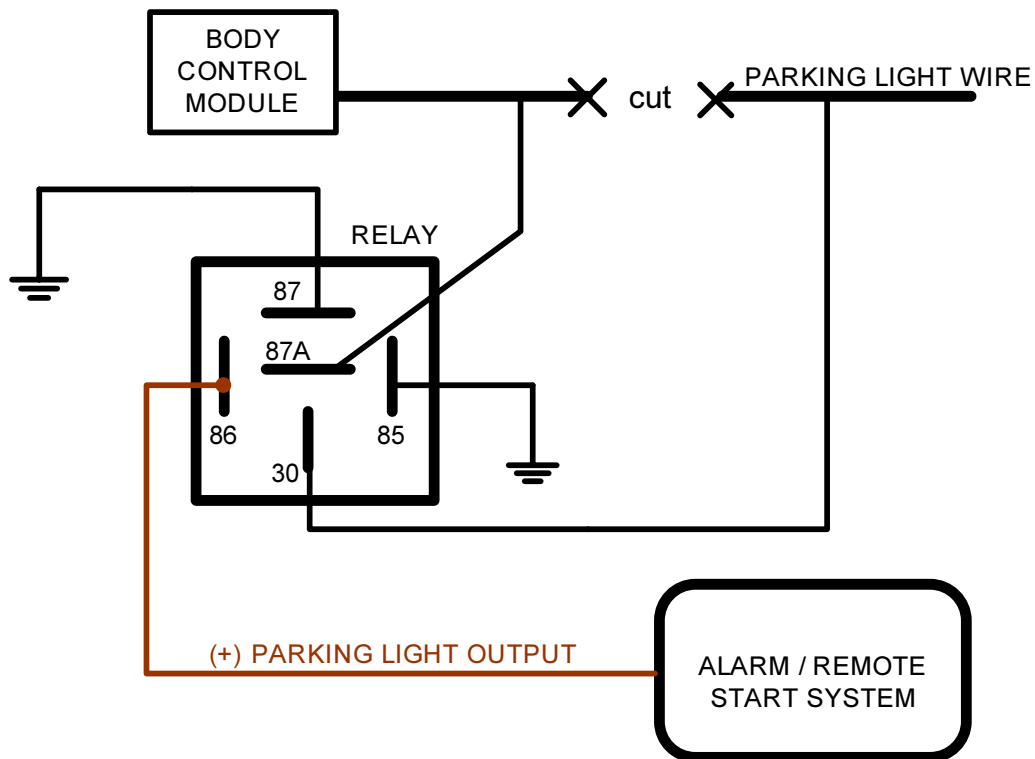
On 2000-Up Chevy Impalas and Monte Carlos, the parking light wire must be isolated from the BCM to avoid the "Service Engine Soon" light from coming on. Cut the wire and

► Use a relay and wire as shown:

PIN	CONNECTION
85	TO CHASSIS GROUND
86	TO (+) PARKING LIGHT OUTPUT FROM ALARM/REMOTE START SYSTEM
87	TO CHASSIS GROUND
87A	TO PARKING LIGHT WIRE – SWITCH SIDE
30	TO PARKING LIGHT WIRE – LIGHT SIDE
